HiWind 2024 Structural Analysis

Andrew Carlile

4/30/2024

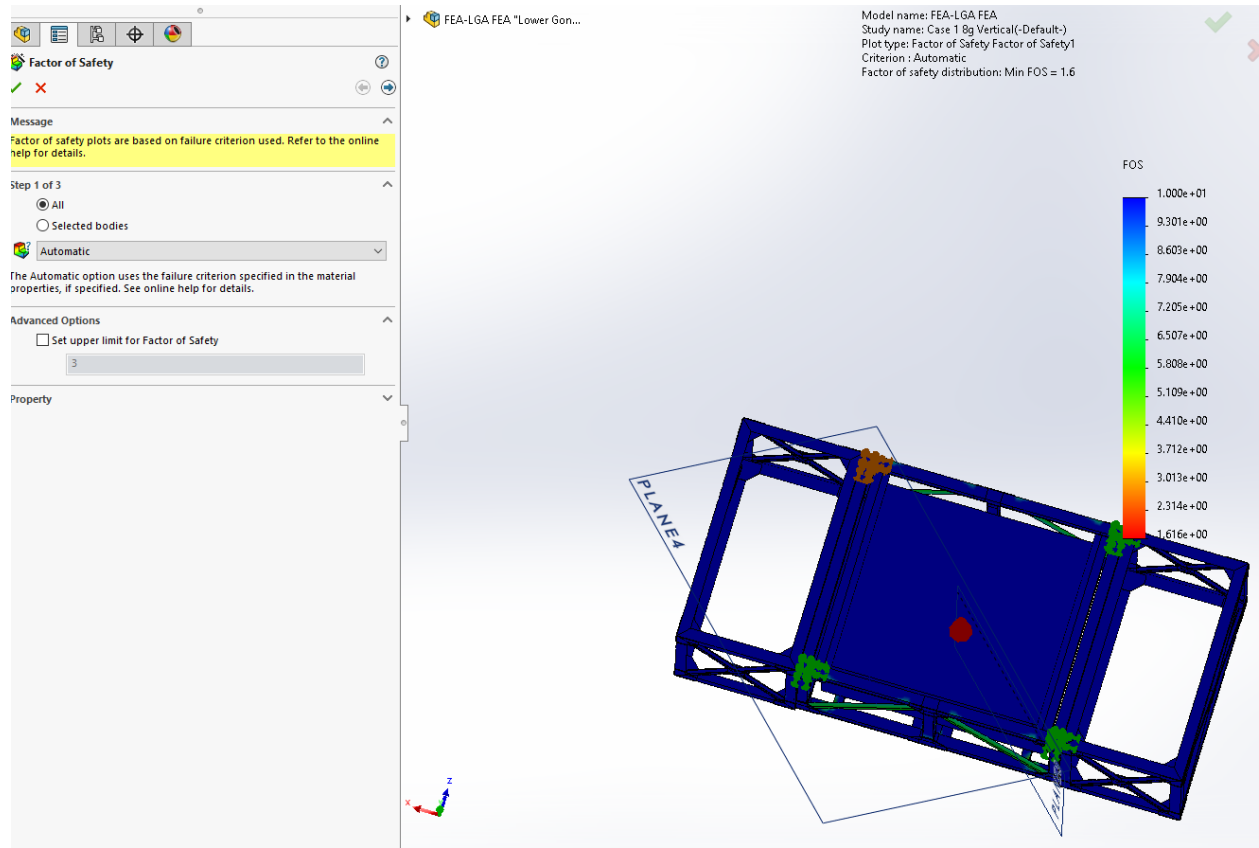
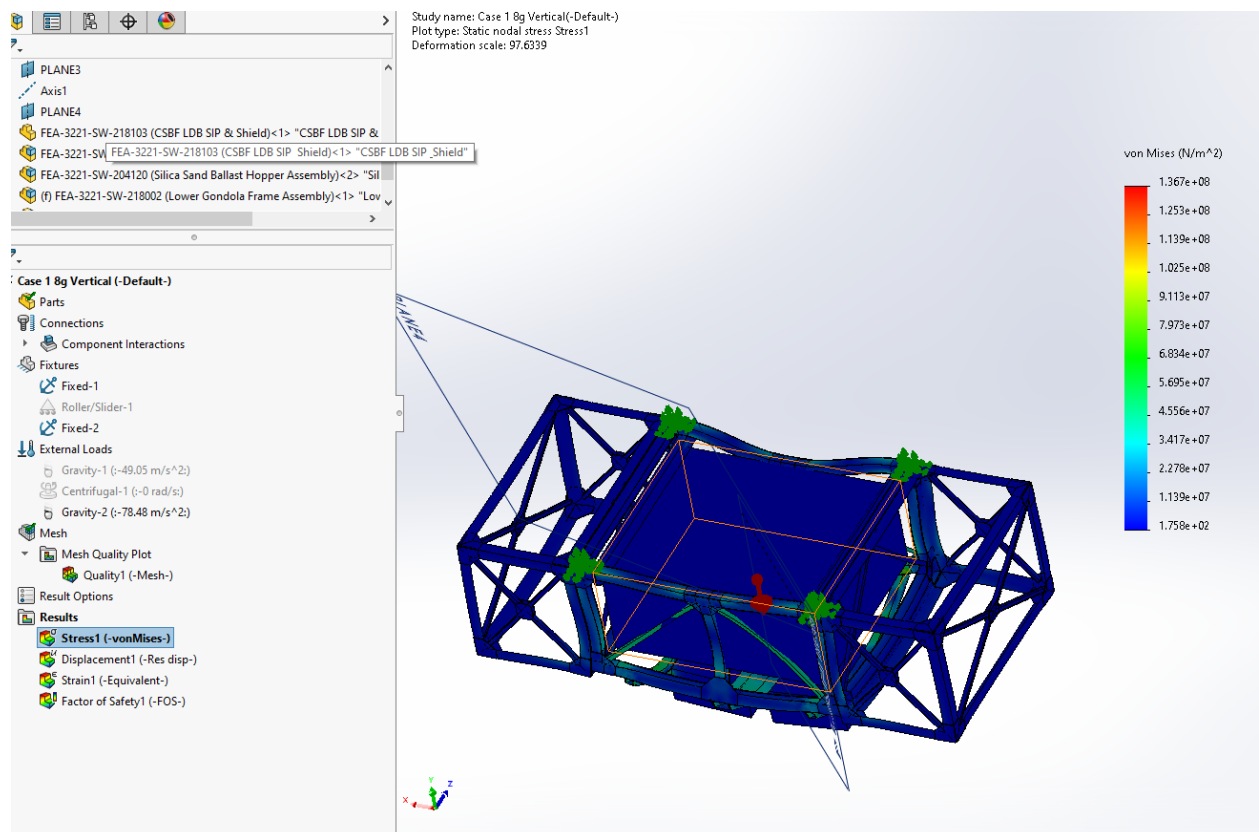
Load Case 1 Lower Gondola

| Case 1 8g Vertical | | | | | | | | |
|---|---|---|---|---|---|---|--|---|
| | MSu | 2.92 | FSu | 1.25 | P | 1.37E+02 MPa | | 1.62 FOS |
| | MSy | 1.27 | FSy | 1.40 | P | 1.37E+02 MPa | | 1.62 FOS |

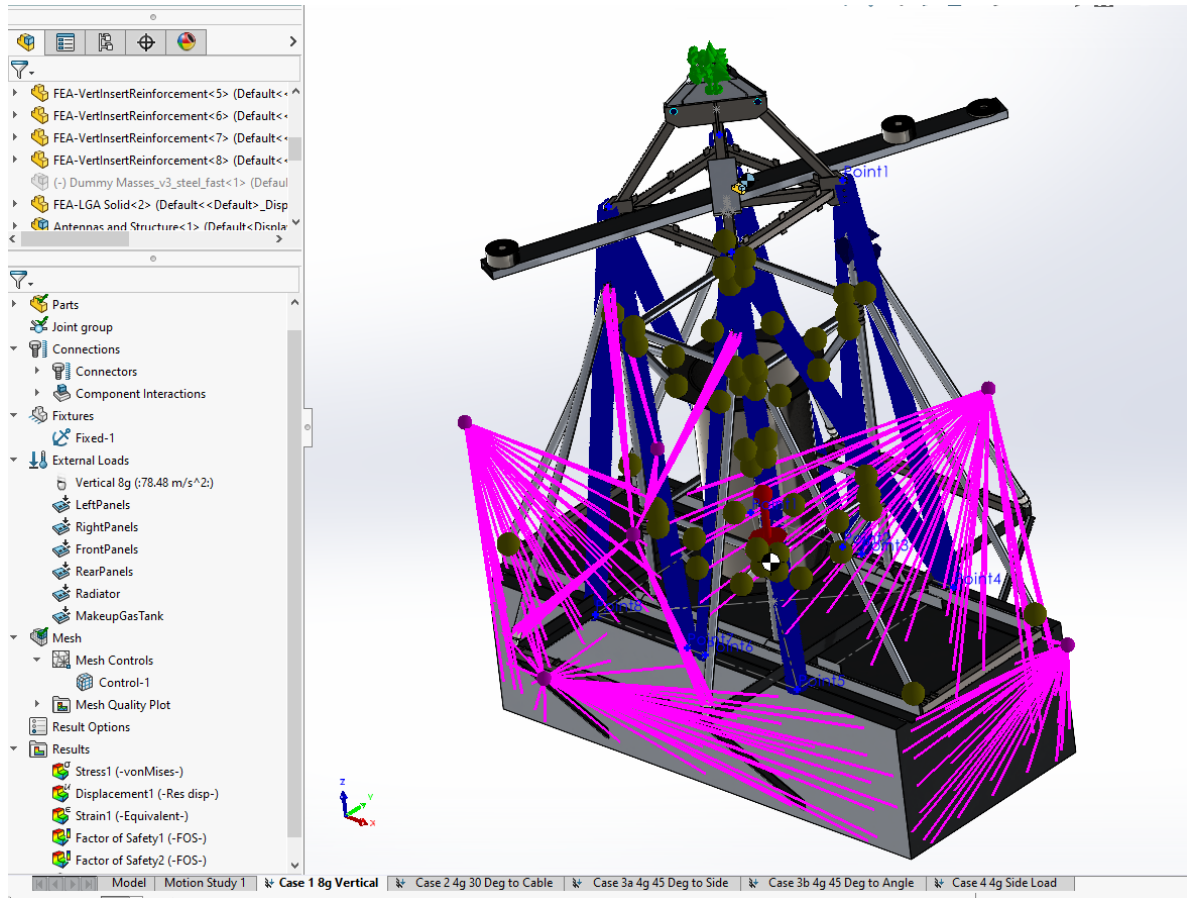
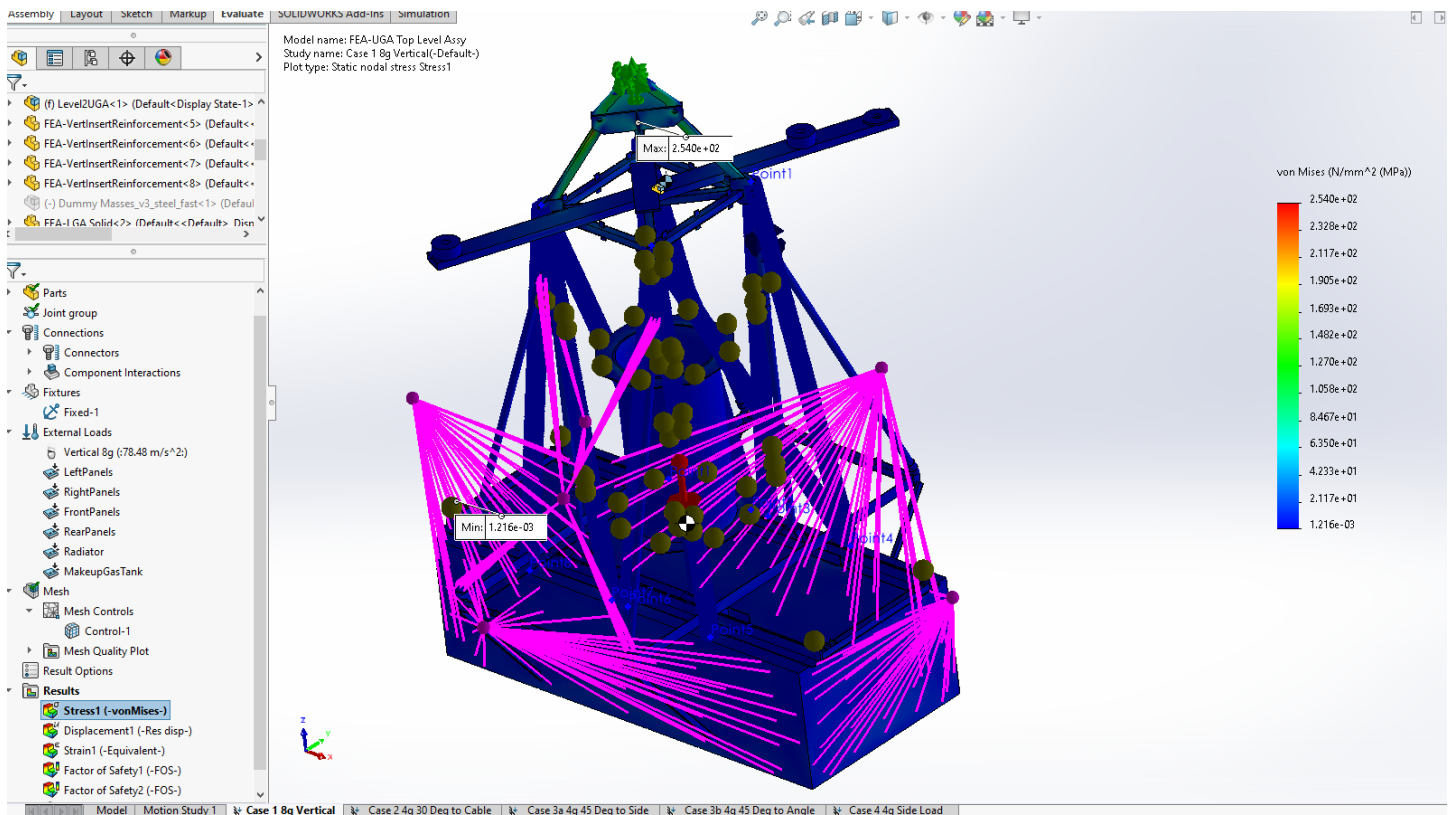
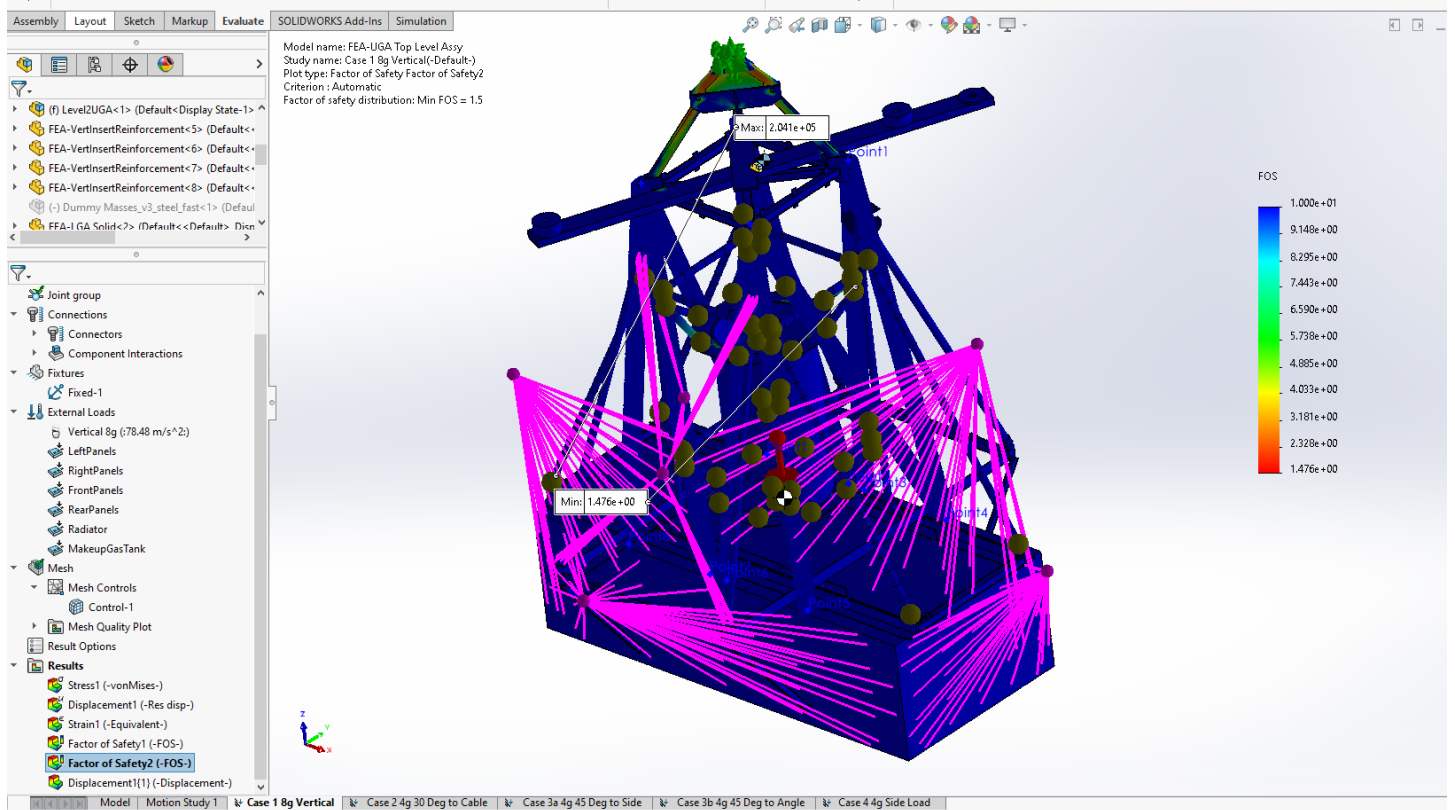
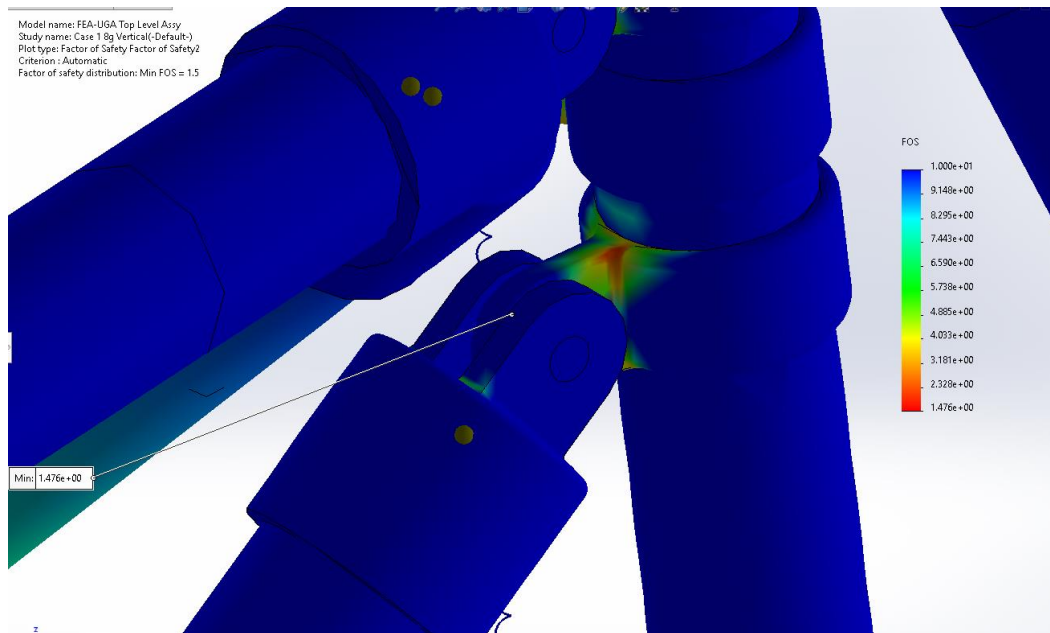
Load Case 1 Upper Gondola

The KeeClamp joining member has a low FOS, the min FOS from the assembly and the max stress of a node in any part will be used in the Safety Factor calculation. Steel is used in the Margin of Safety calculation as the material, as the fastener taking the load is steel.

| Case 1 8g Vertical | | | | | | | | |
|---|---|---|---|---|---|---|--|---|
| | MSu | 1.11 | FSu | 1.25 | P | 2.54E+02 MPa | | 1.48 FOS |
| | MSy | 0.22 | FSy | 1.40 | P | 2.54E+02 MPa | | 1.48 FOS |

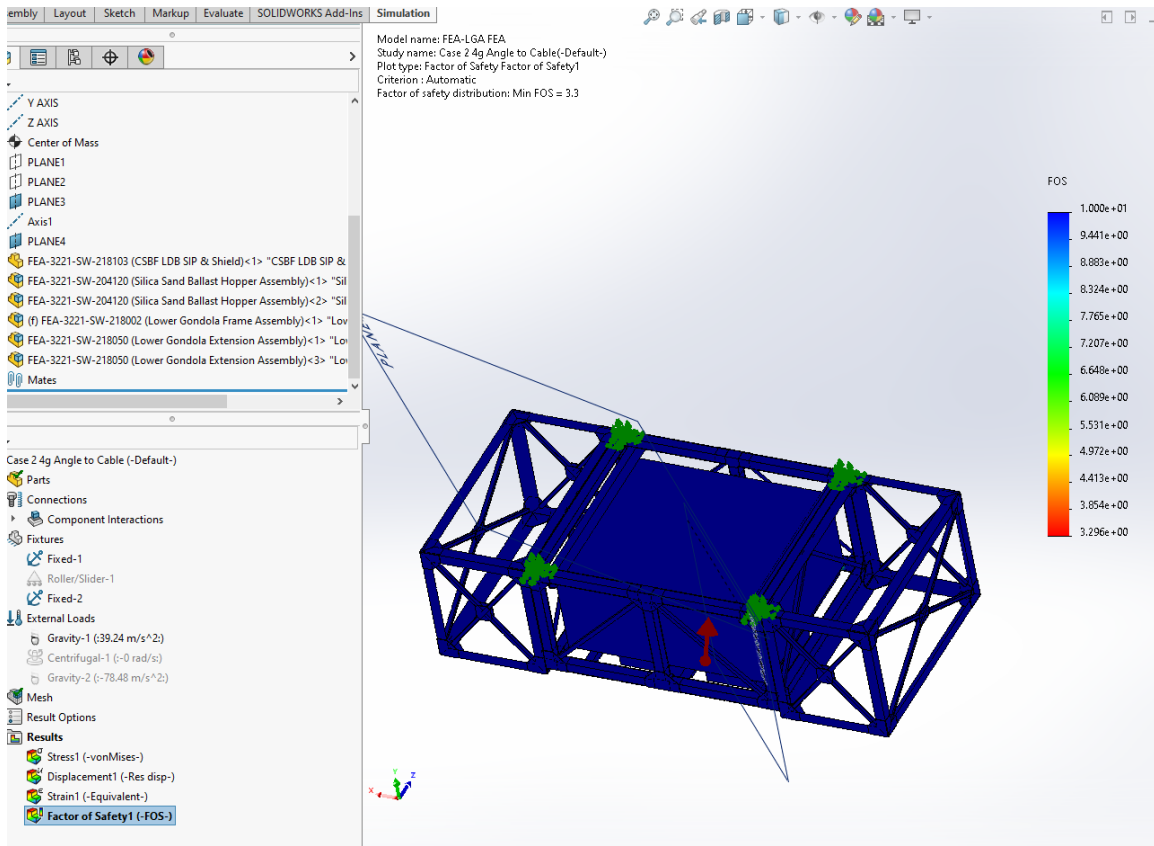
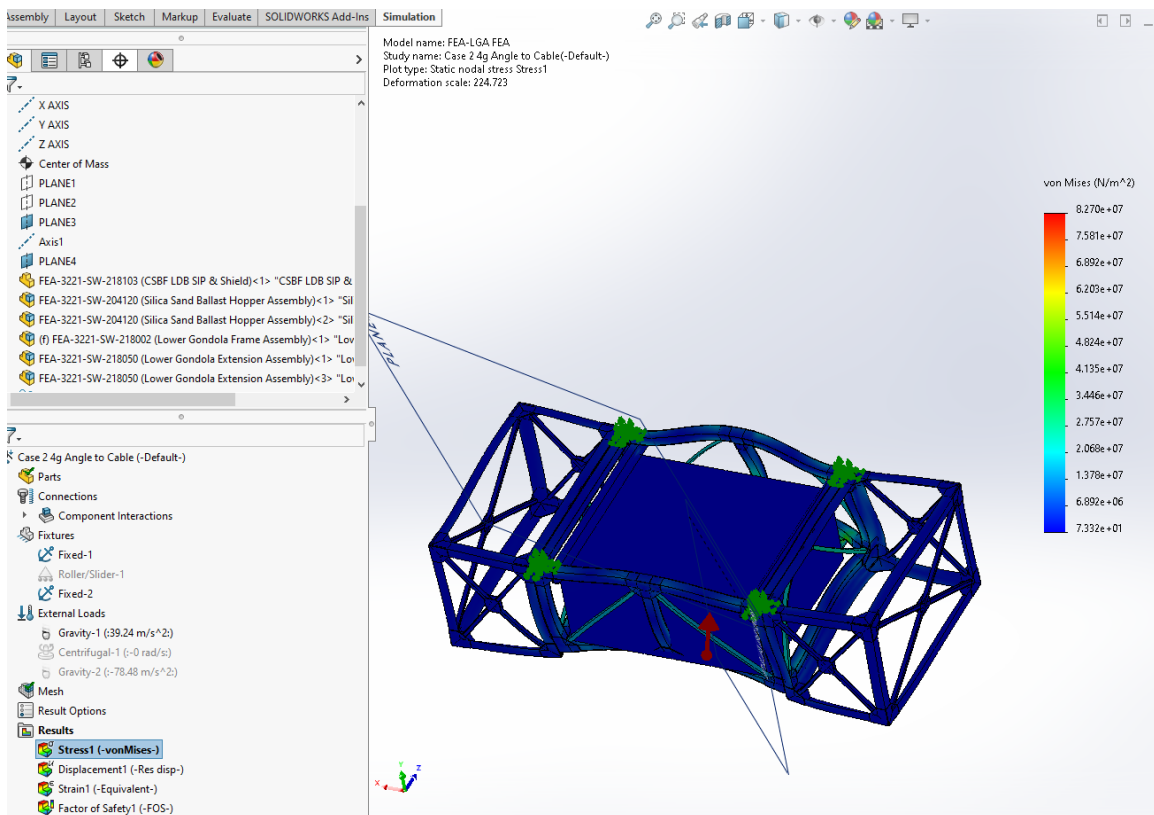
Load Case 2 Lower Gondola

| Case 2 4g 30 Degree to Cable | | | | From NASA | Maximum From FEA | Minimum From FEA | |
|---|---|---|---|---|---|---|---|
| | MSu | 5.48 | FSu | 1.25 | P 8.27E+01 MPa | 3.30 | FOS |
| | MSy | 2.76 | FSy | 1.40 | P 8.27E+01 MPa | 3.30 | FOS |

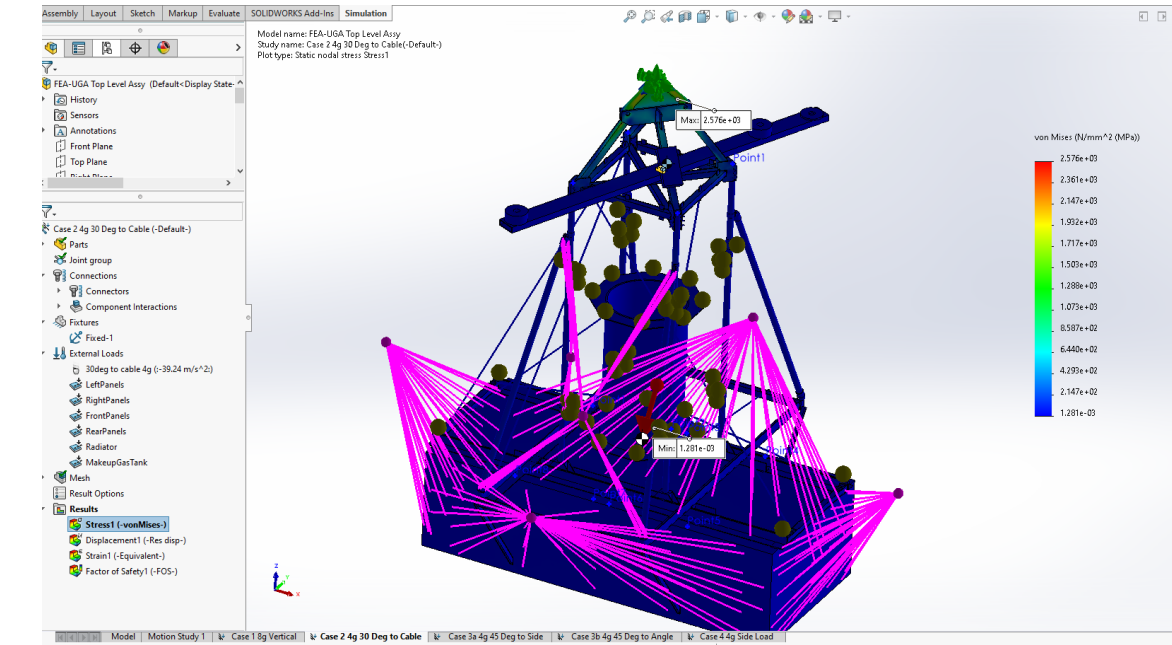
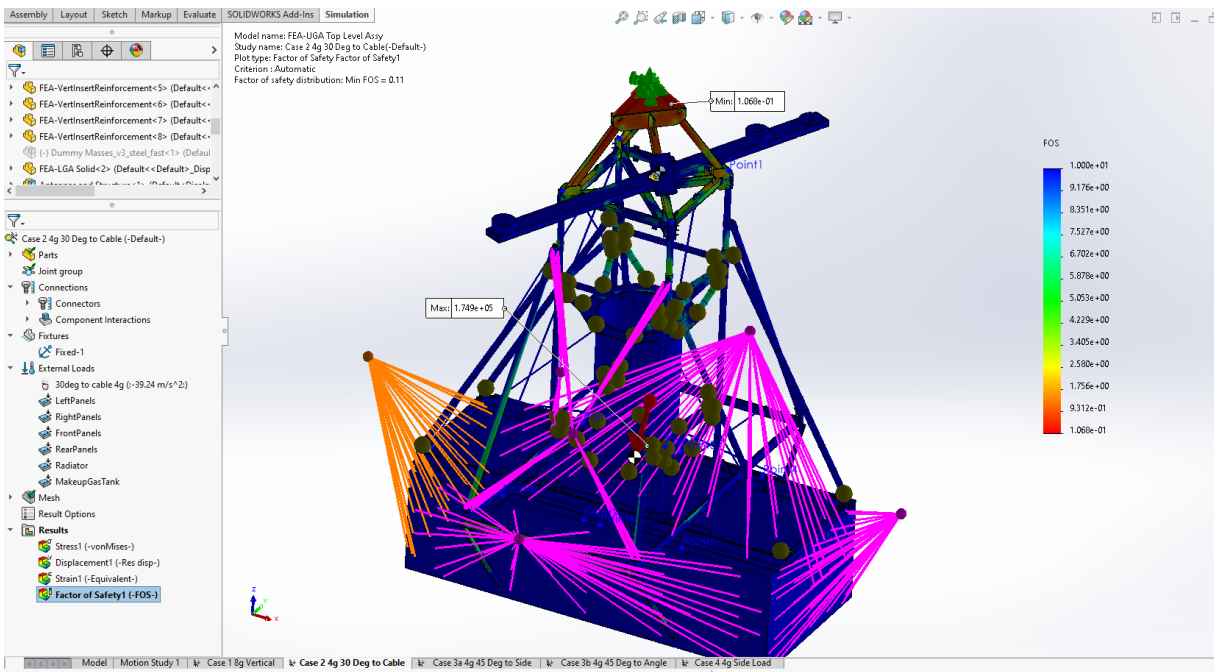
Load Case 2 Upper Gondola

The upper gondola does not pass this case. The lowest factor of safety is in the triplate.

| Case 2 4g 30 Degree to Cable | | | | From NASA | Maximum From FEA | Minimum From FEA | |
|---|---|---|---|---|---|---|---|
| | MSu | -0.90 | FSu | 1.25 | P 2.58E+03 MPa | 0.11 | FOS |
| | MSy | -0.92 | FSy | 1.40 | P 2.58E+03 MPa | 0.11 | FOS |

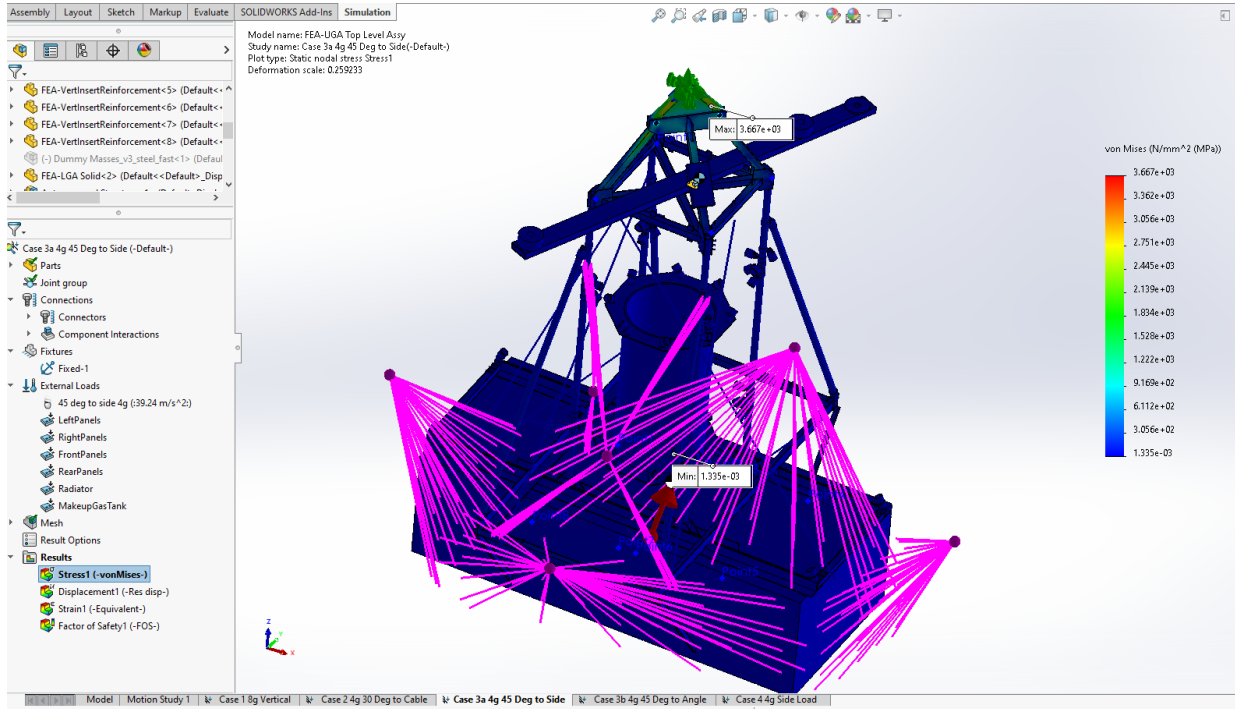
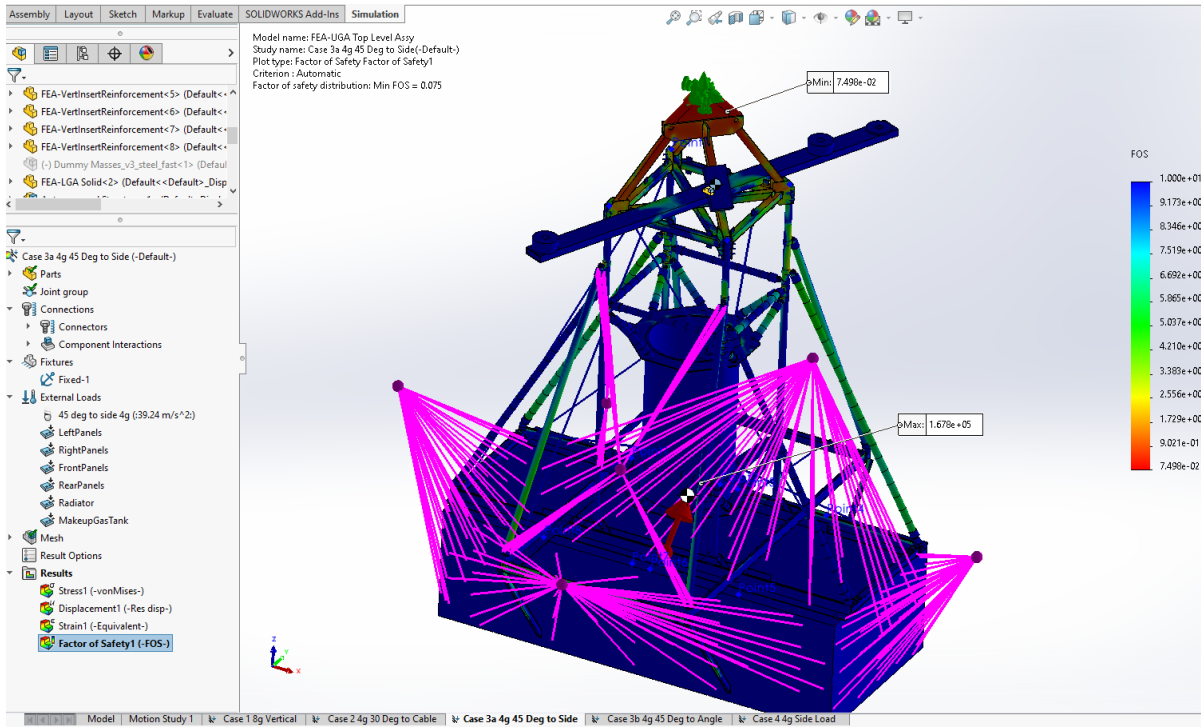
Load Case 3a Upper Gondola

| | | From NASA | Maximum From FEA | Minimum From FEA | | |
|---|---|---|---|---|---|--|
| MSu | -0.93 | FSu 1.25 | P 3.67E+03 MPa | 0.08 | FOS | |
| MSy | -0.95 | FSy 1.40 | P 3.67E+03 MPa | 0.08 | FOS | |

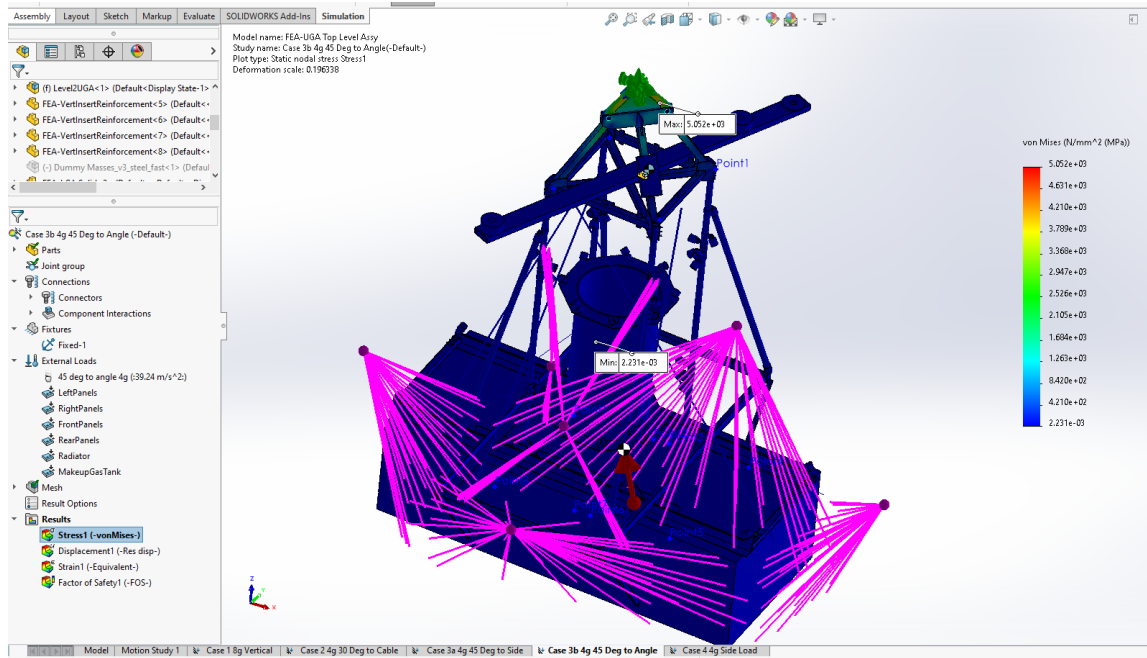
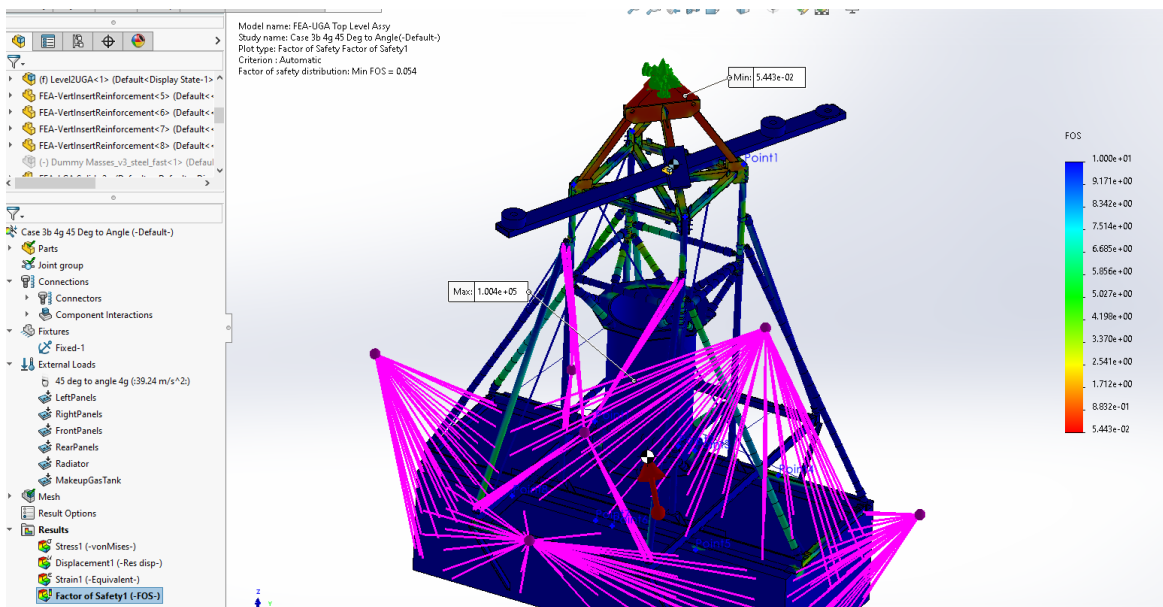
Load Case 3b Upper Gondola

| Case 3b 45 Degree to Vertical | | | | | | | | |
|---|---|---|---|---|---|---|--|---|
| | MSu | -0.95 | FSu | 1.25 | P | 5.05E+03 MPa | | 0.05 FOS |
| | MSy | -0.96 | FSy | 1.40 | P | 5.05E+03 MPa | | 0.05 FOS |

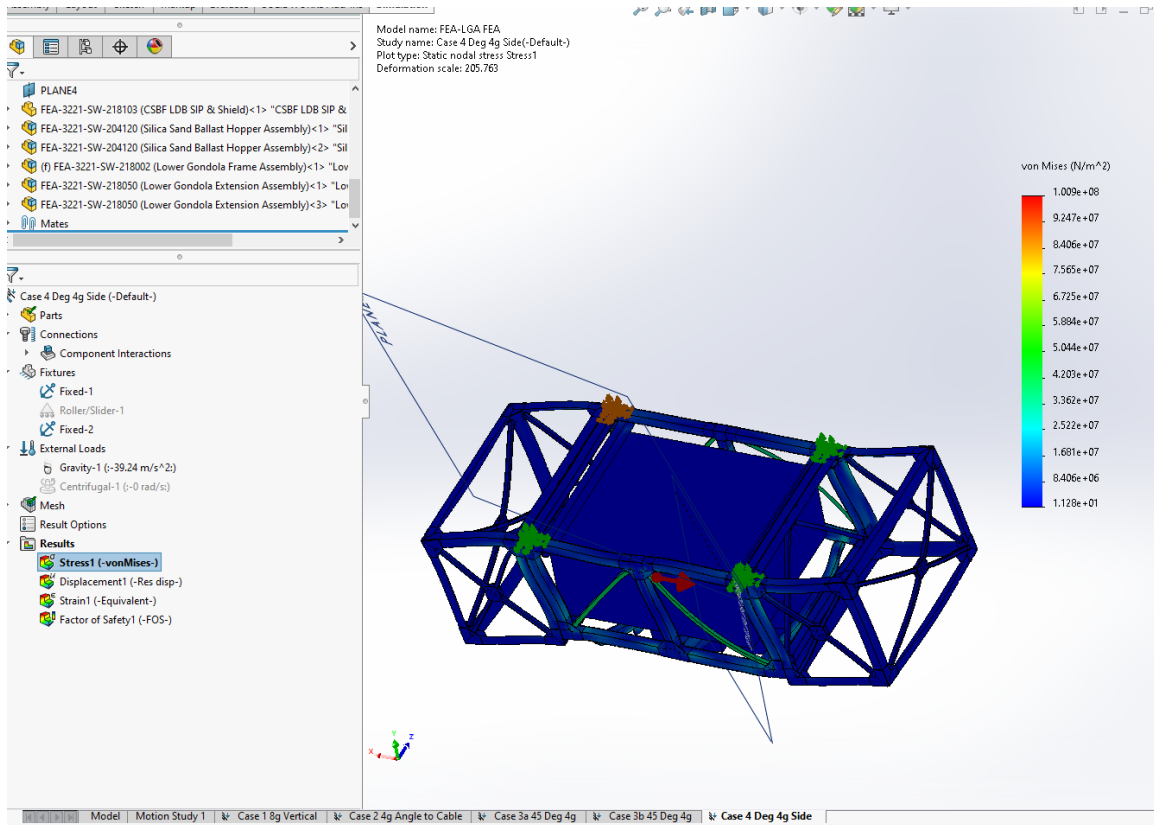
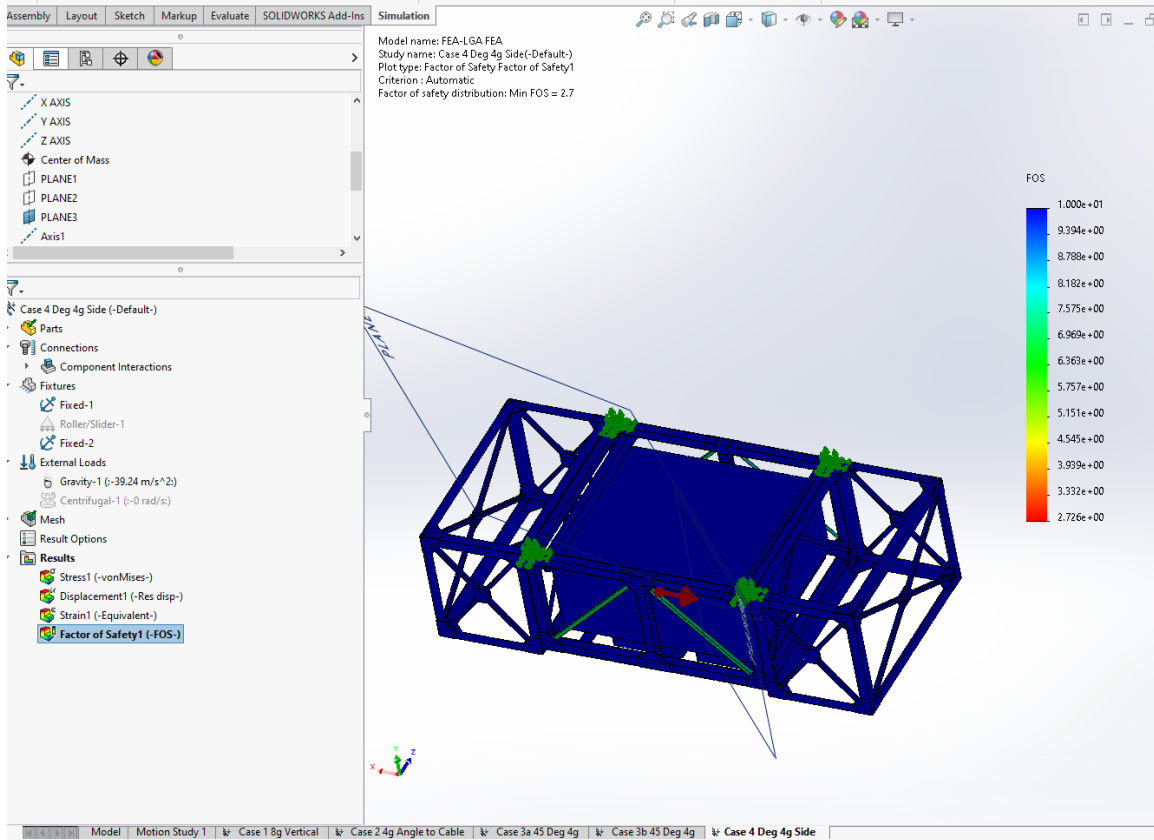
Load Case 4 Lower Gondola

| Case 4 4g Side Load | | | From NASA | | Maximum From FEA | | Minimum From FEA | |
|---|---|---|---|---|---|---|---|---|
| | MSu | 4.31 | FSu | 1.25 | P | 1.01E+02 MPa | 2.73 | FOS |
| | MSy | 2.08 | FSy | 1.40 | P | 1.01E+02 MPa | 2.73 | FOS |

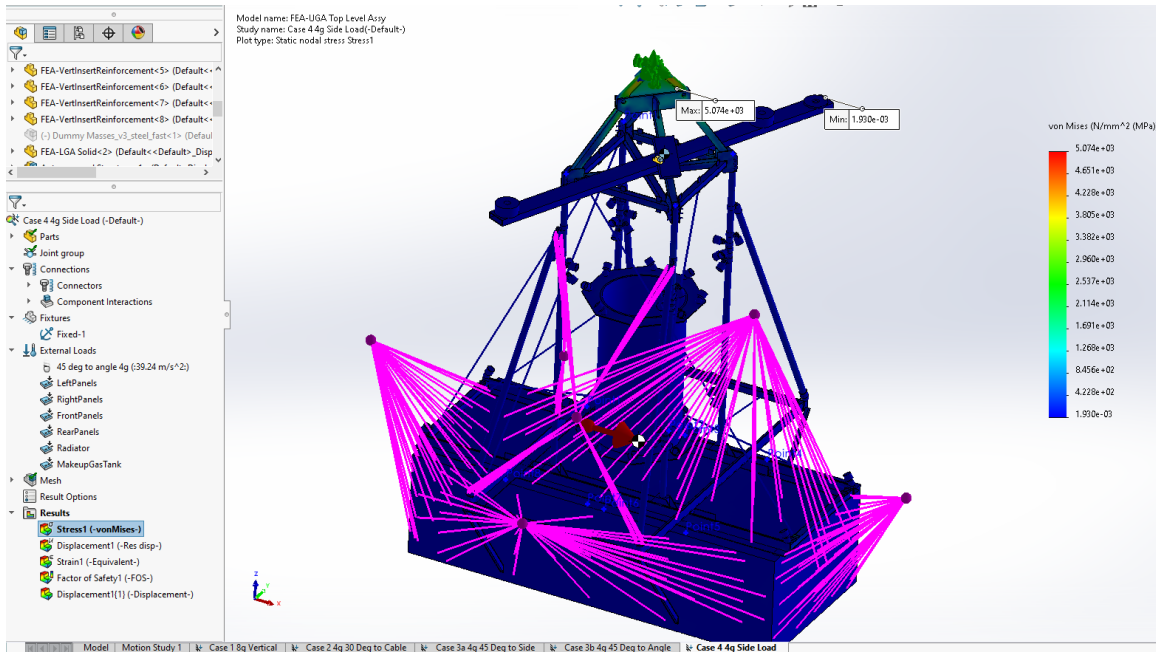
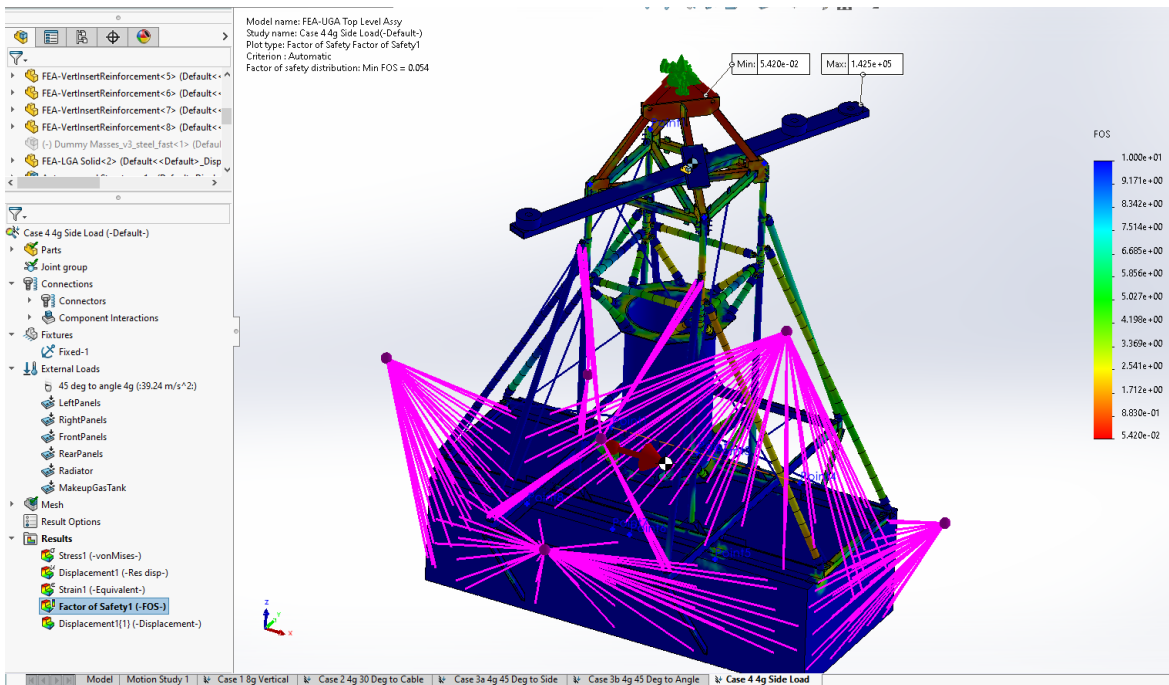
Load Case 4 Upper Gondola

| Case 4 4g Side Load | | | From NASA | | Maximum From FEA | | Minimum From FEA | |
|---|---|---|---|---|---|---|---|---|
| | MSu | -0.95 | FSu | 1.25 | P | 5.10E+03 MPa | 0.05 | FOS |
| | MSy | -0.96 | FSy | 1.40 | P | 5.10E+03 MPa | 0.05 | FOS |

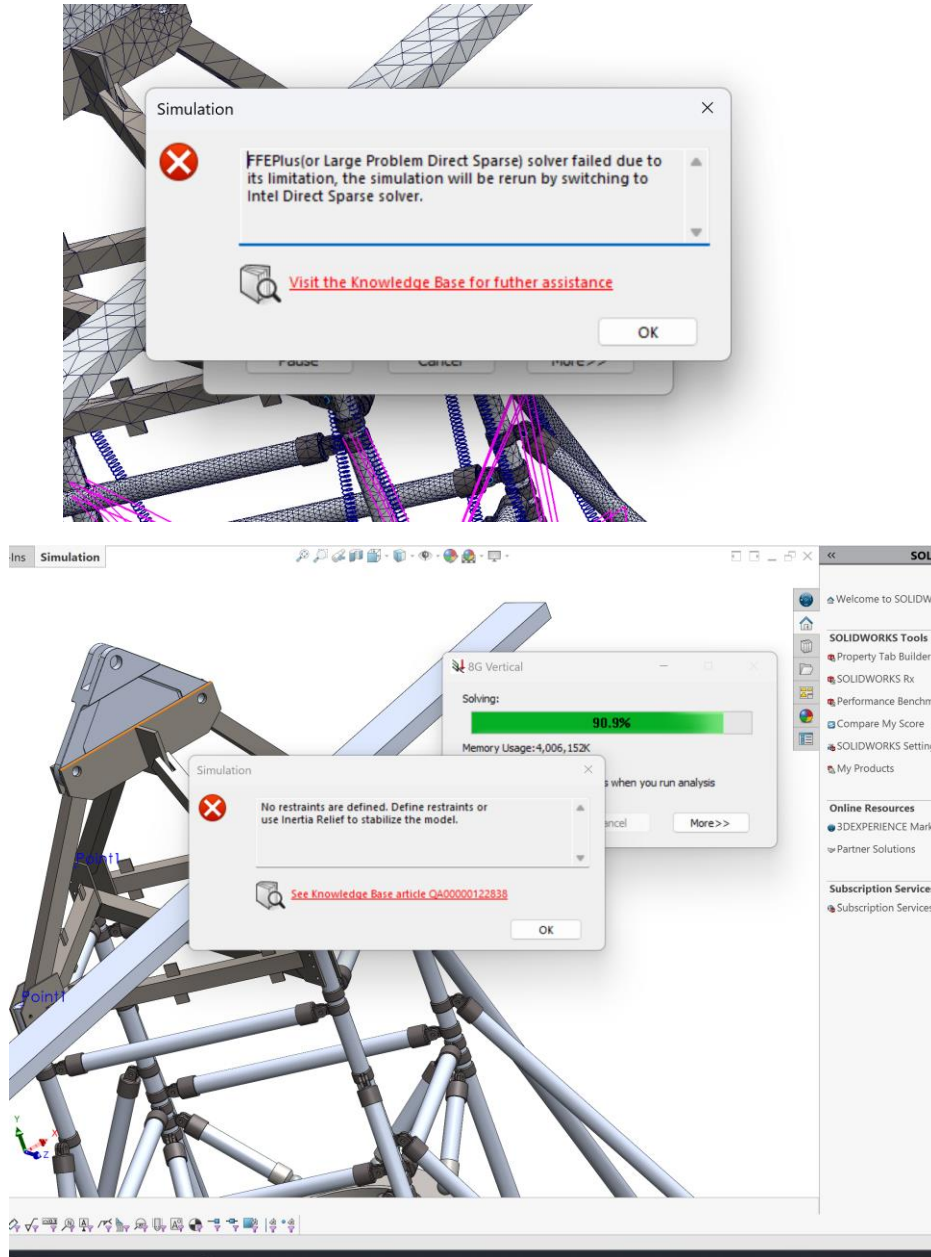
Analysis Errors

The tri-plate being fixed and using the gravity vector load with the dummy masses was used because the inertial relief style of analysis has serious problems meshing and converging on a solution. The high quality mesh never completed an analysis run.

Exception code 0xc0000005 thrown at address 0x1405f7612.
